Illinois Commerce Commission  
Assessment of Commonwealth Edison Company  
Reliability Report and Reliability Performance  
for Calendar Year 2004

Pursuant to 83 Ill. Adm. Code 411.140

December 23, 2005

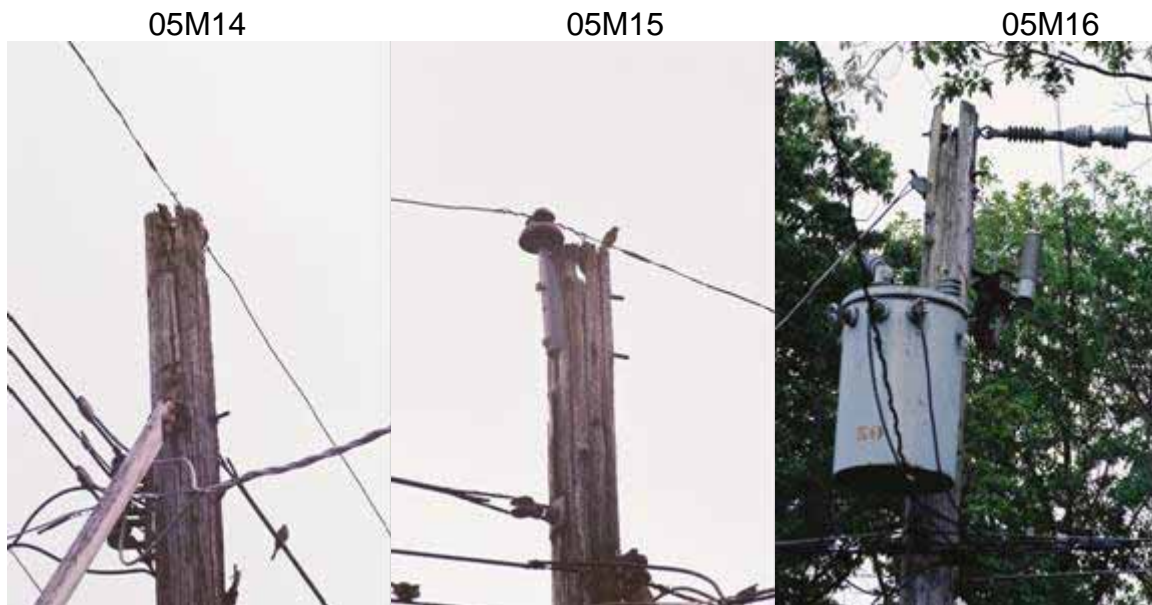
Photo 05M16 is of a ComEd pole in front of 923 E. Fellows.

Photos 05M14 & 15 are of a ComEd pole on E. Fellows St. just west of Jefferson (in front of 526 E. Fellows). That pole is also missing a guy marker.

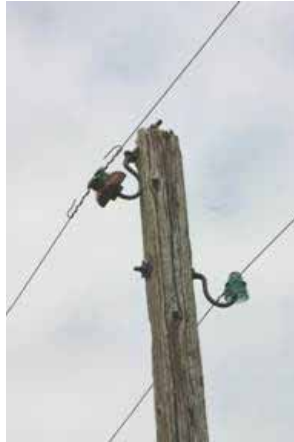
Photo 106-0612 (8/31/05).....Primary "J" bracket falling off badly shell rotted pole, on Kishwaukee Rd. between Belvidere and Woodstock west of Garden Valley Rd. (4<sup>th</sup> pole east of transformer 350013A).

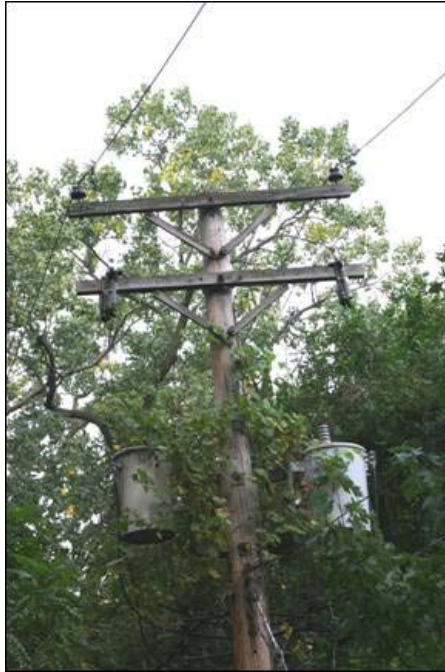
Grapevines up pole & onto transformers, on Court Street south of Washington Street, Joliet.
